Investigation of Floor Vibrations in the "D" Wing of the Main Building of the Bureau of Engraving and Printing

Prepared for
Bureau of Engraving and Printing
4th and C Streets, S.W.
Washington, D.C. 20228

NBSIR 82-2599

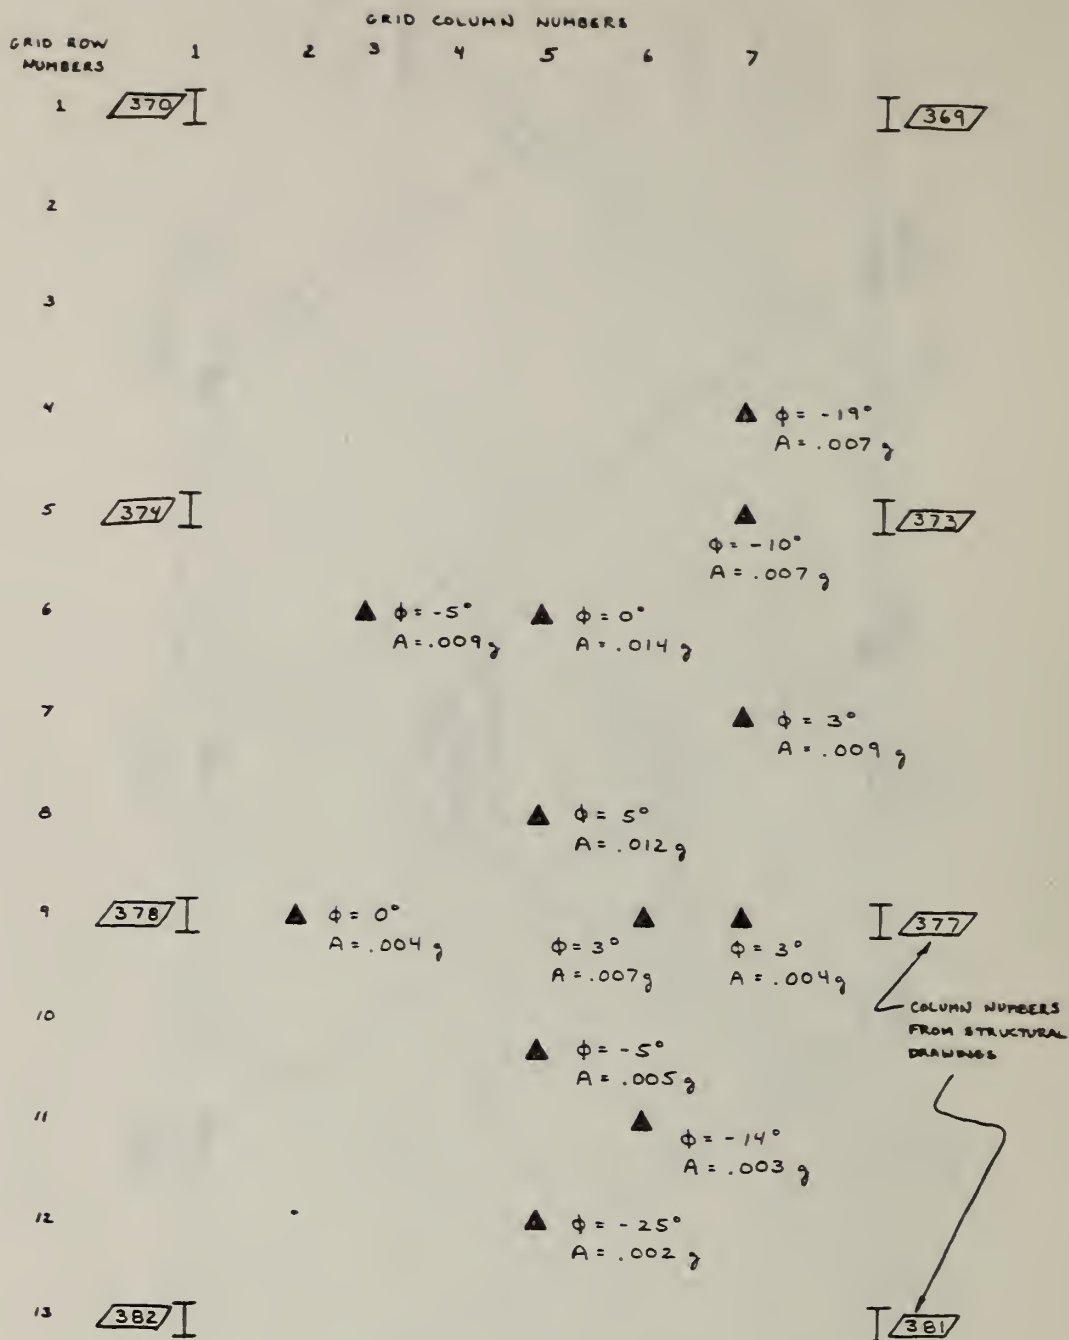
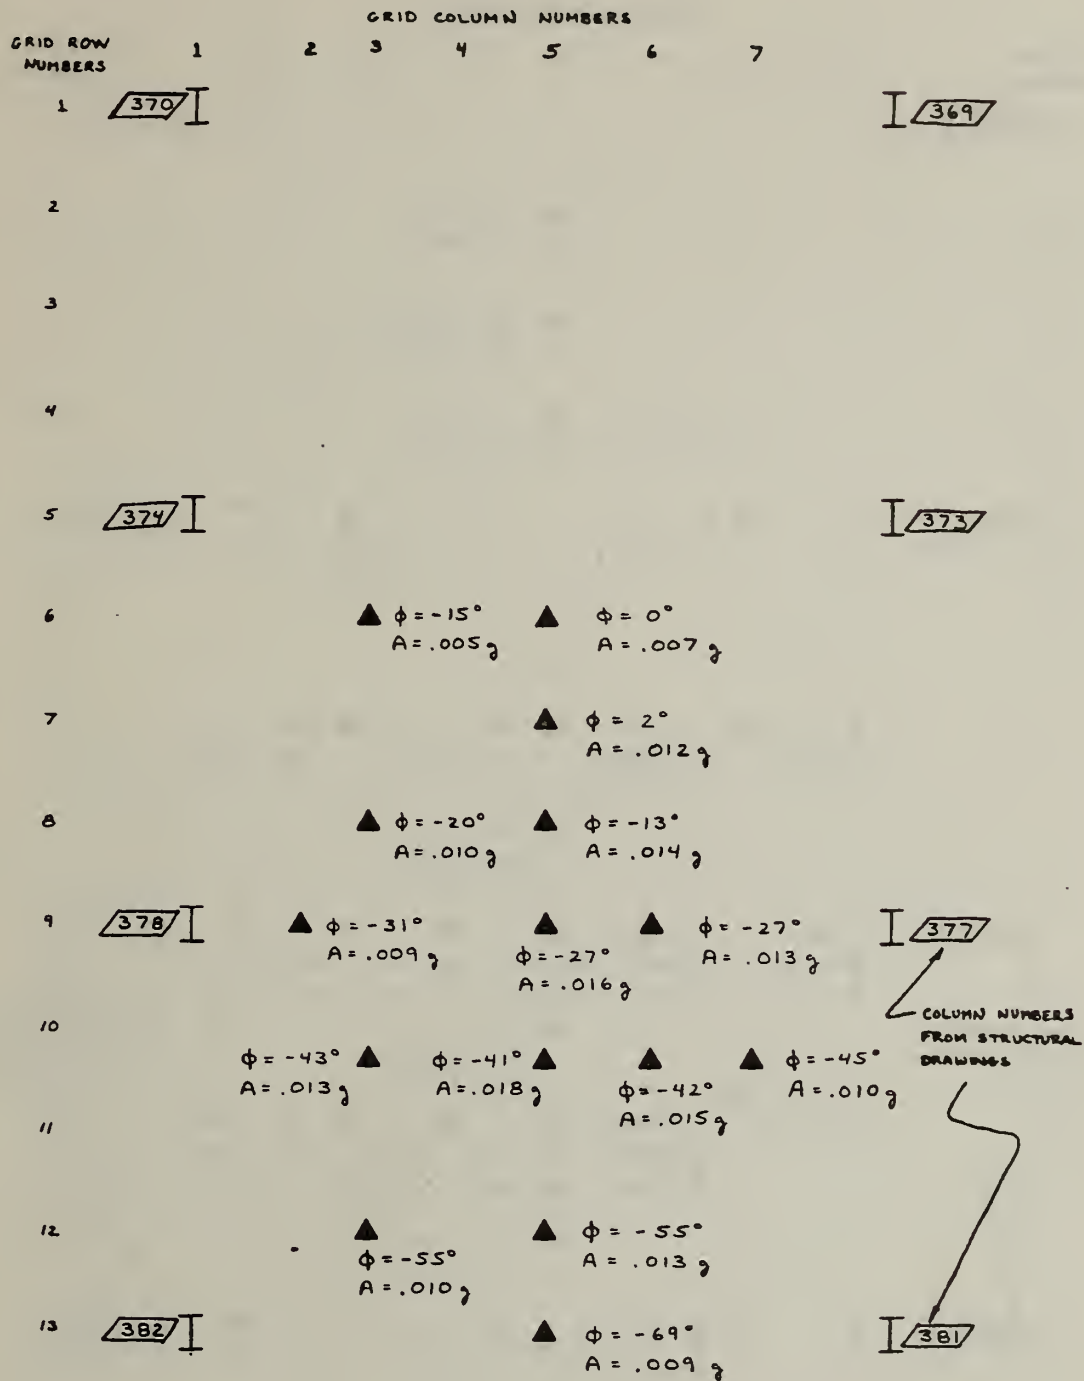
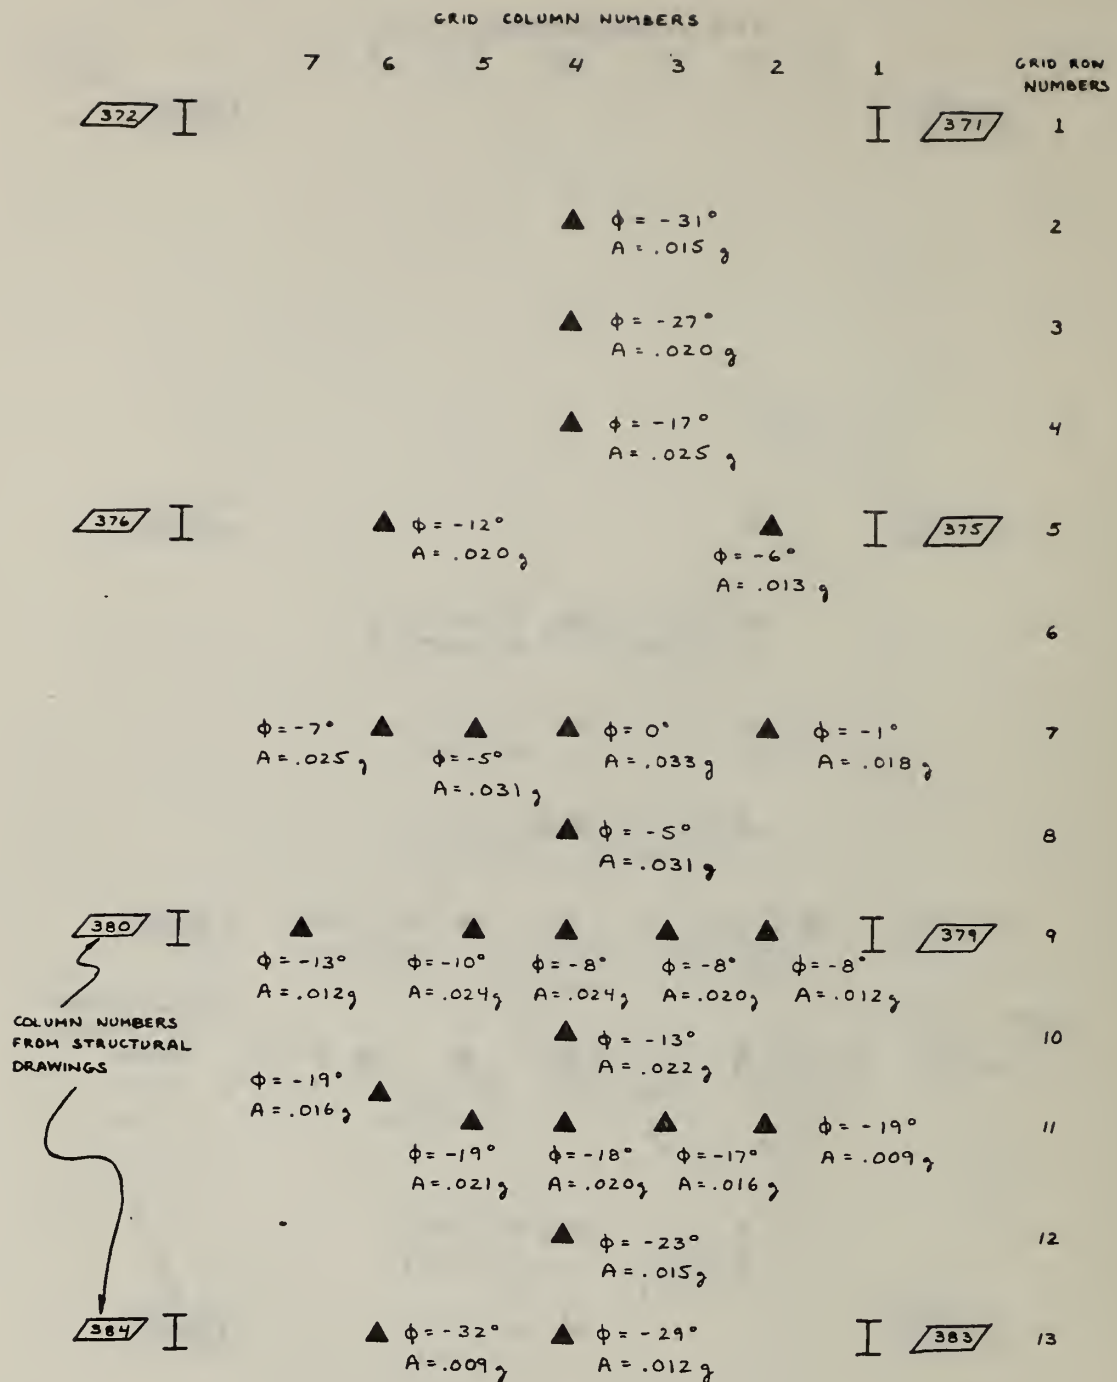
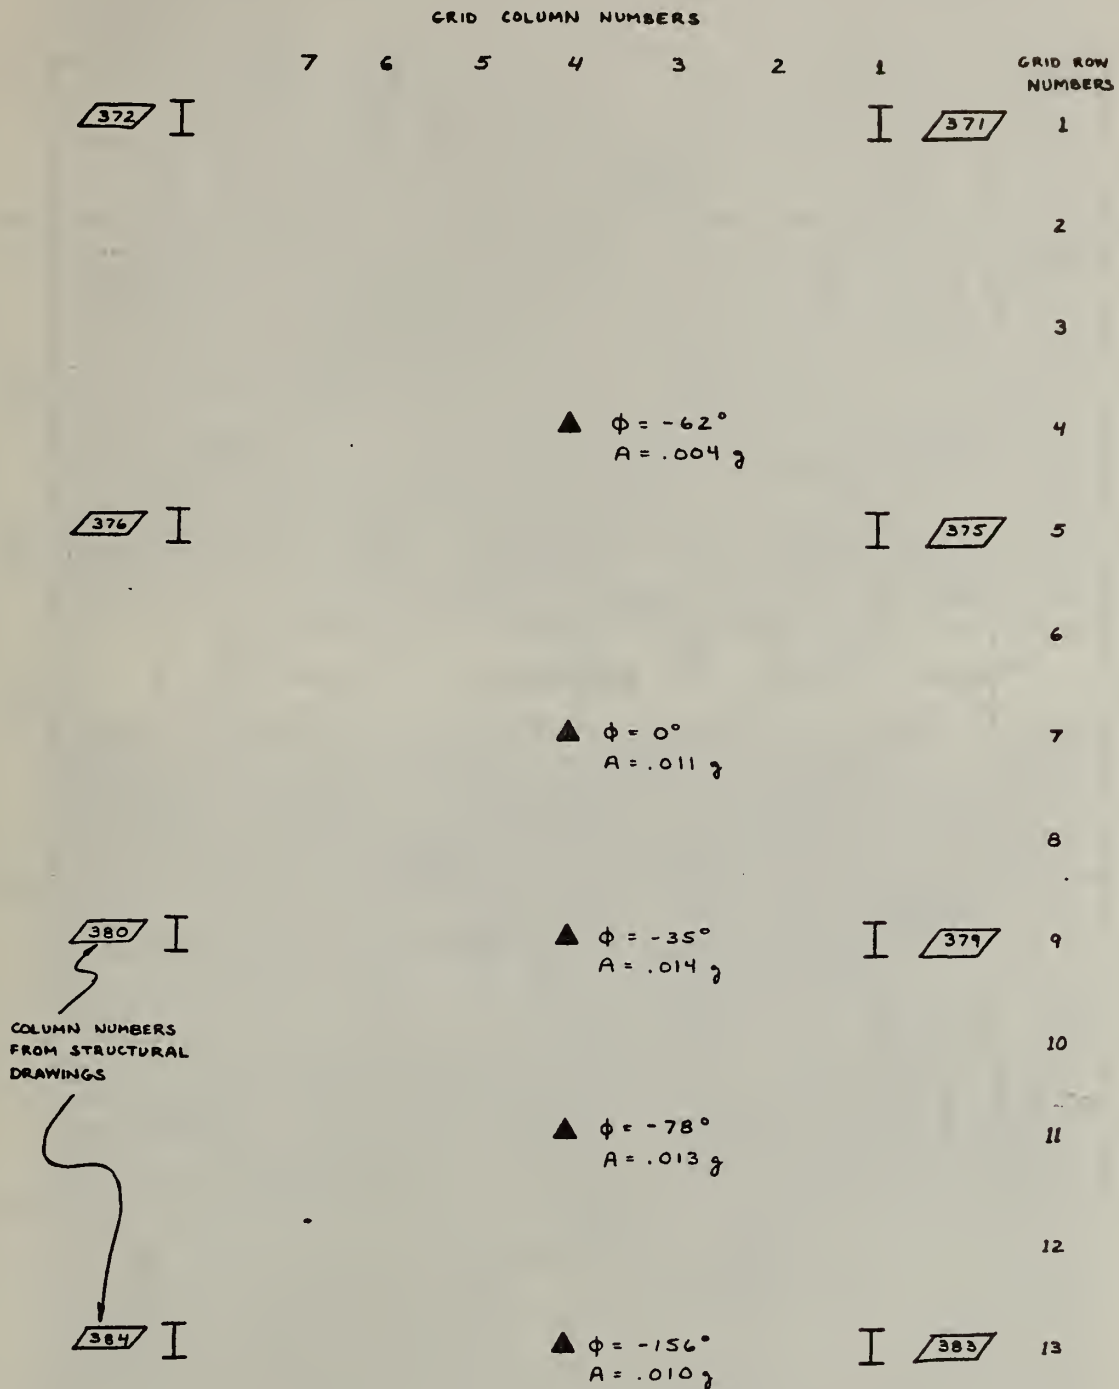
Rms acceleration levels, A , and relative phase angles, ϕ , of the floor system response are shown in Figs. 14, 15, 16 and 17. Velocities and displacements are tabulated along with accelerations and phase angles in Tables 1, 2, 3 and 4. During analysis of vibration data from the tests of the South floor, with a machine web speed of approximately 117 feet/minute, it was found that accelerations measured at the reference location varied significantly between different tests. These differences are attributable to either a degradation of the connection between the reference accelerometer and the floor since later tests produced lower accelerations than earlier tests, or to slightly different operating speeds since the machine stopped several times and had to be restarted during the course of testing all the locations. Results presented in Table 3a correspond to actual measurements, while values in Table 3b are corrected to reflect the possibility that different machine speeds caused the observed differences.

The phase angles shown in Figs. 14, 15, 16 and 17 indicate that the vibration propagates out from the middle of the span on which the perforator is located. This is an indication that at the measured frequency the forced vibration induced by the machine was not precisely in resonance with the floor. Therefore, it may be possible to generate a somewhat larger response than that observed in the NBS tests.

FIG. 14: Acceleration Data and Phase Relationships for North Floor Vibrations with Machine Web Speed of 125 Feet/Minute.

FIG. 15: Acceleration Data and Phase Relationships for North Floor Vibrations with Machine Web Speed of 155 Feet/Minute.

FIG. 16: Corrected Acceleration Data and Phase Relationships for South Floor Vibrations with Machine Web Speed of 117 Feet/Minute.

FIG. 17: Acceleration Data and Phase Relationships for South Floor Vibrations with Machine Web Speed of 160 Feet/Minute.

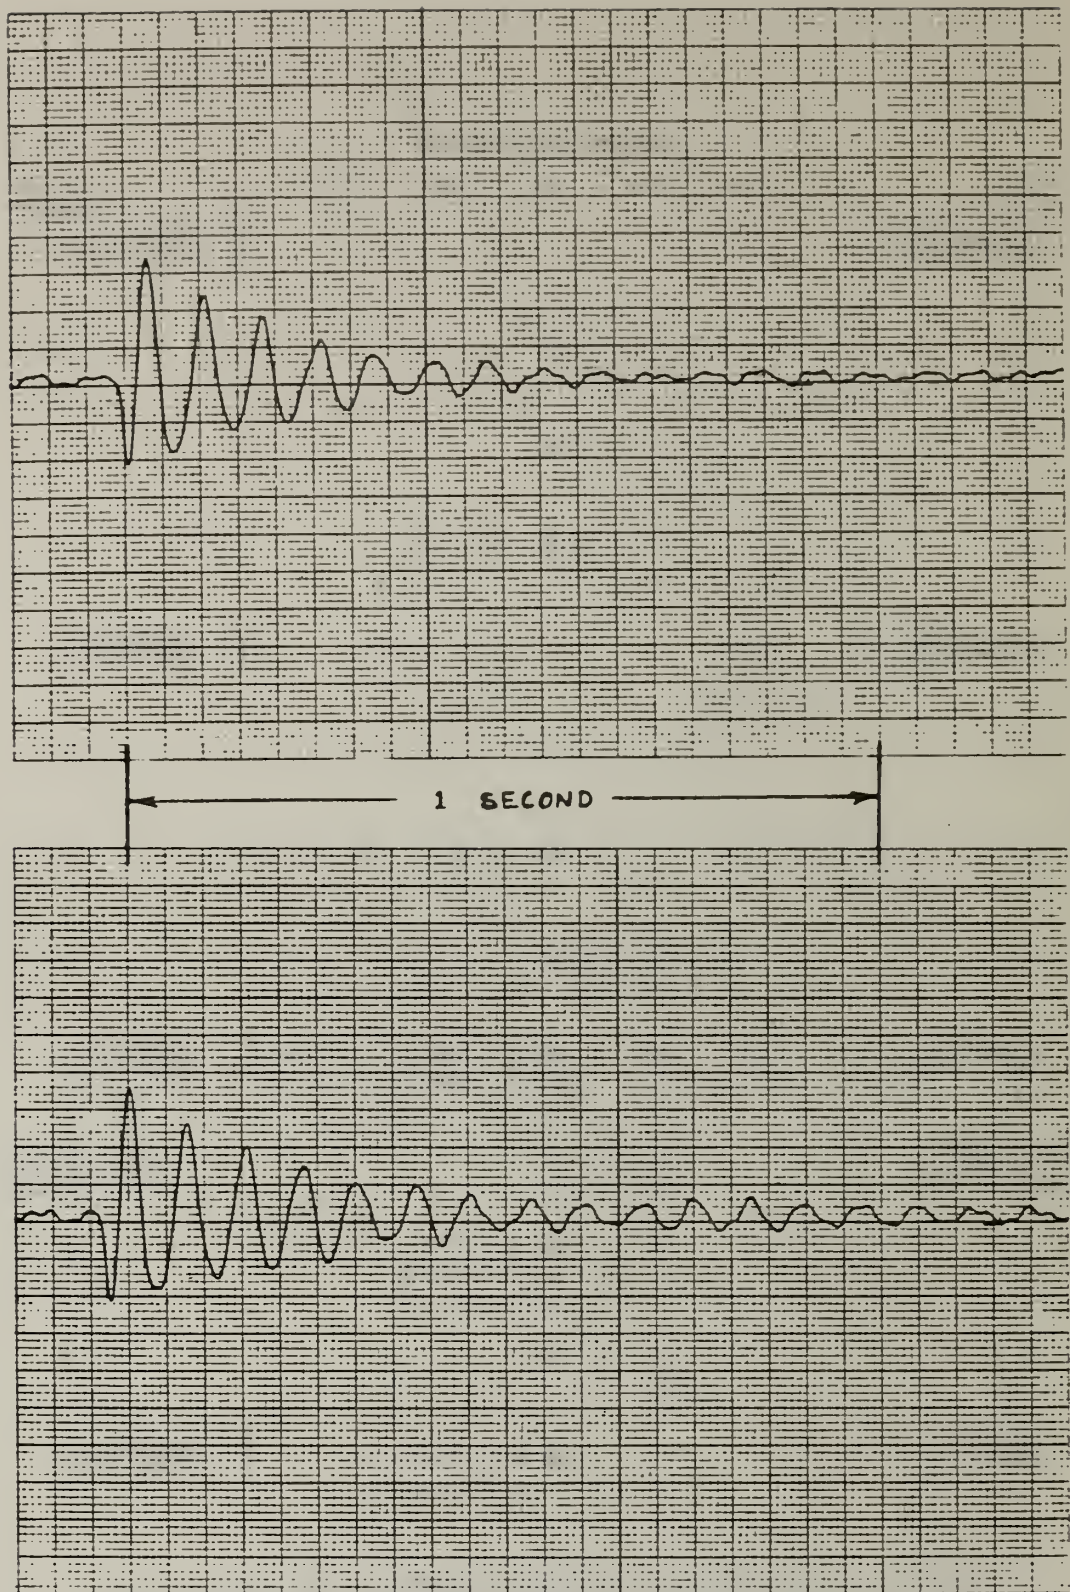
2. Damping ratio for the south floor: 6 percent of critical damping.

A trace of the impact test is shown in Fig. 18.

FIG. 18: Strip Chart Records of Acceleration
Traces From Impact Tests at Locations
7, 4.

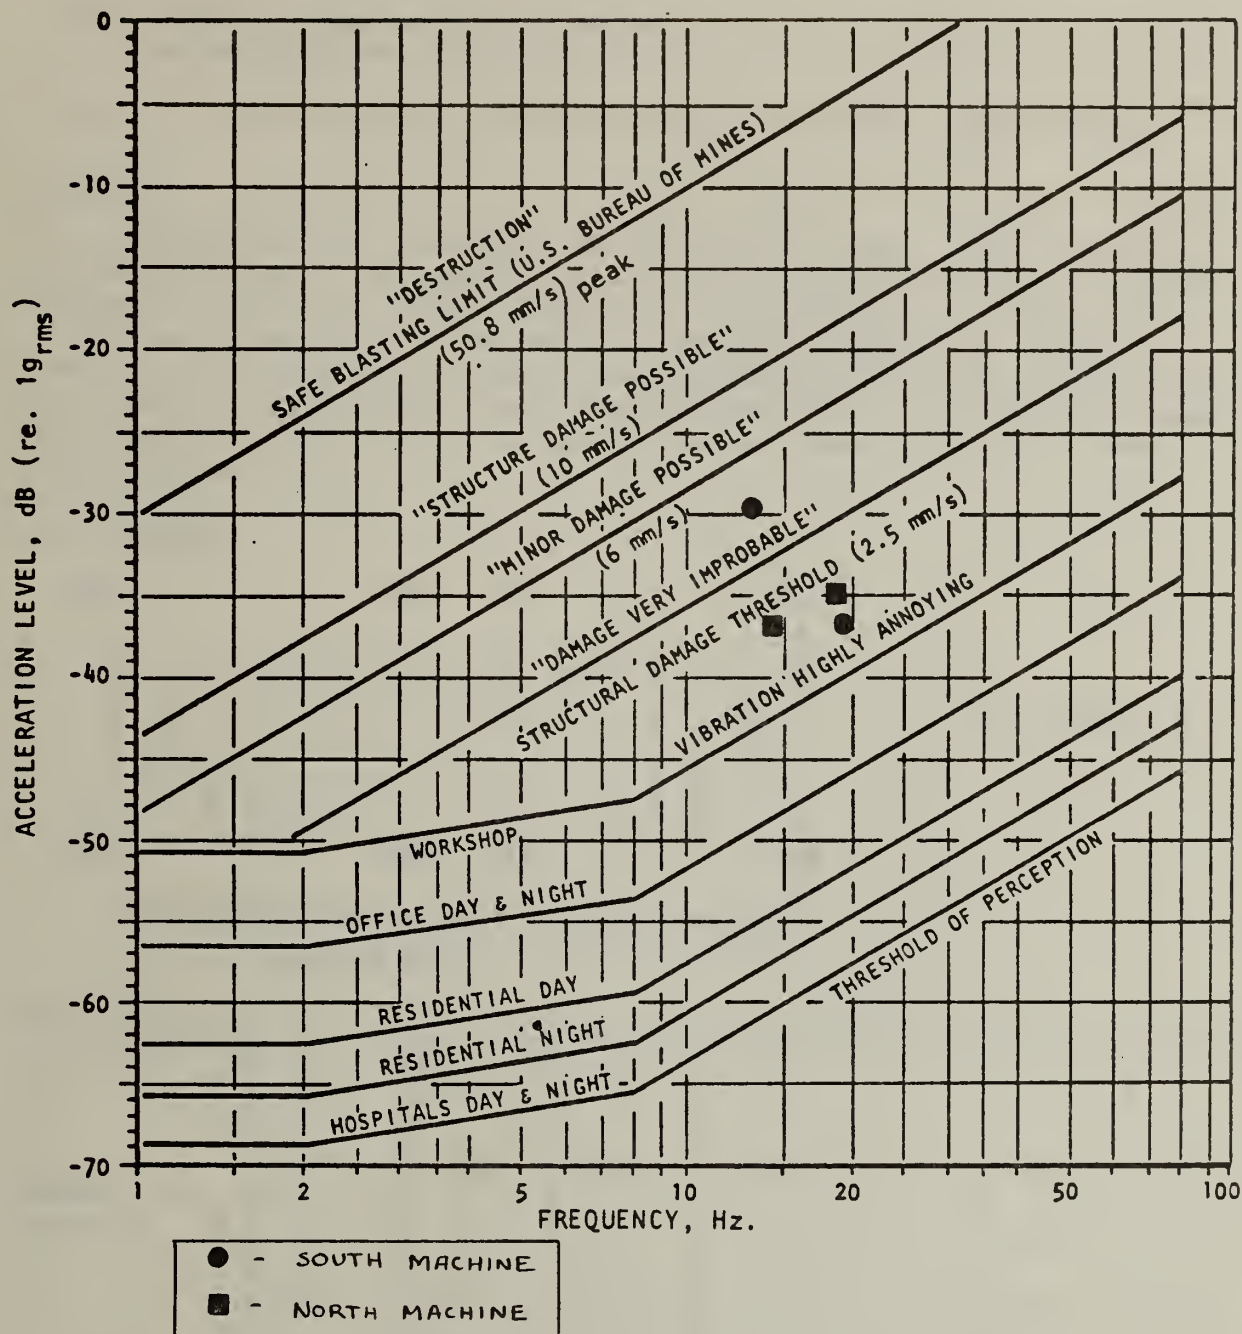
The maximum values of accelerations, velocities and displacements are given in Table 5. Maximum acceleration levels were evaluated against empirical criteria for structural vibrations presented in Ref. [1] and shown in Fig. 17. In Fig. 19, circles denote accelerations for south floor locations and squares denote north floor locations. Note that all vibrations are below the threshold for "minor damage," and that the south floor vibrations are above the line indicating "damage very improbable." All maximum vibrations, however, are above the threshold for "highly annoying vibrations" for work areas. This fact is also corroborated by the perception of workers in the area.

Since the maximum vibrations are slightly above the threshold for possible (though not probable) structural damage (2.5 mm/s or 0.1 in/s), a more complete analysis of vibration-induced stresses was conducted.

FIG. 19: Comparison of Maximum Measured Accelerations Against Empirical Criteria for Structural Vibrations Suggested in Reference 1.

2) It is suggested that in future purchases of new machines, forced vibrations in the frequency range between 10 and 25 Hz be avoided, or appropriate measures be taken to reduce floor vibrations. It may also be possible to stipulate that induced floor vibrations should not exceed those defined by the "workshop" threshold in Fig. 17.

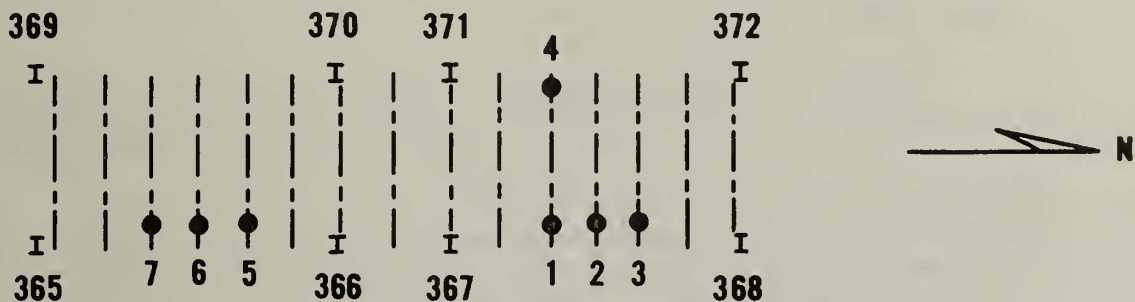
The investigation was carried out on December 17, 1981. Tests were made on the underside of the concrete joist of the first floor near the joist supports. Test locations are shown in the attached sketch. The test locations are identified in the sketch by numbers 1 through 7. Column locations are identified by their reference numbers in the construction plans. The concrete surfaces where tests were conducted were cleaned by the Bureau of Engraving and Printing personnel with a wire brush in order to remove whitewash and dirt.

Note: Numbers denote column locations designated in the building plans.
